historic downtown LOS ANGELES design guidelines

july 2002

DESIGN GUIDELINES INTRODUCTION

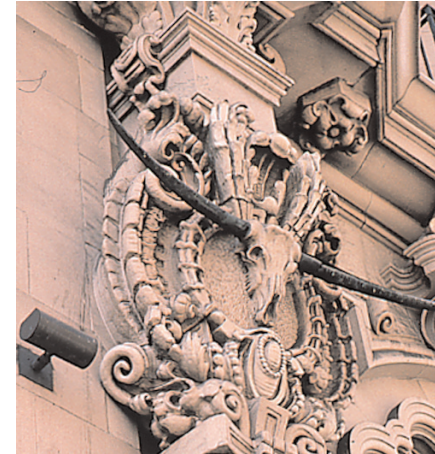
These decorative, terra cotta elements are character-defining features and should be retained and rehabilitated.

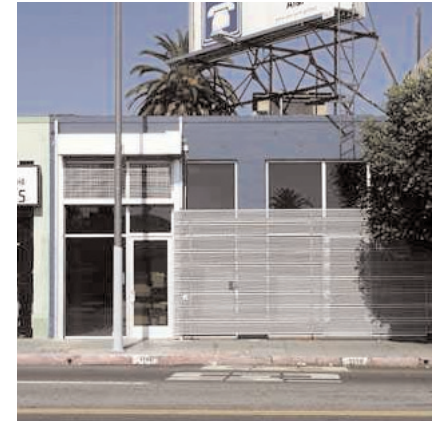
Use security grilles rather than roll-down doors as they provide both security and visibility into the storefront.

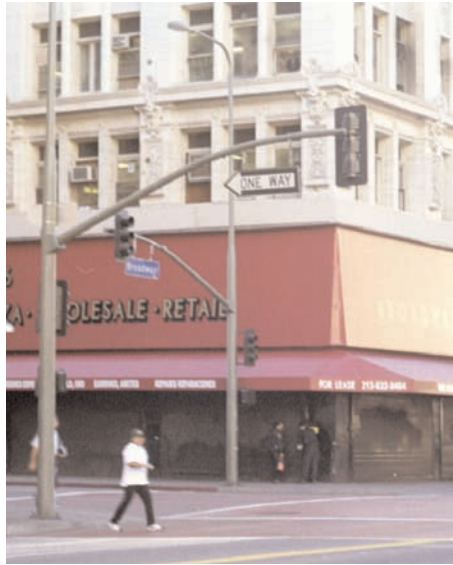
Some building owners have implemented interim solutions such as this awning, which unifies the storefront. In the future, the building owner could restore the transom windows and provide individual awnings for each storefront.

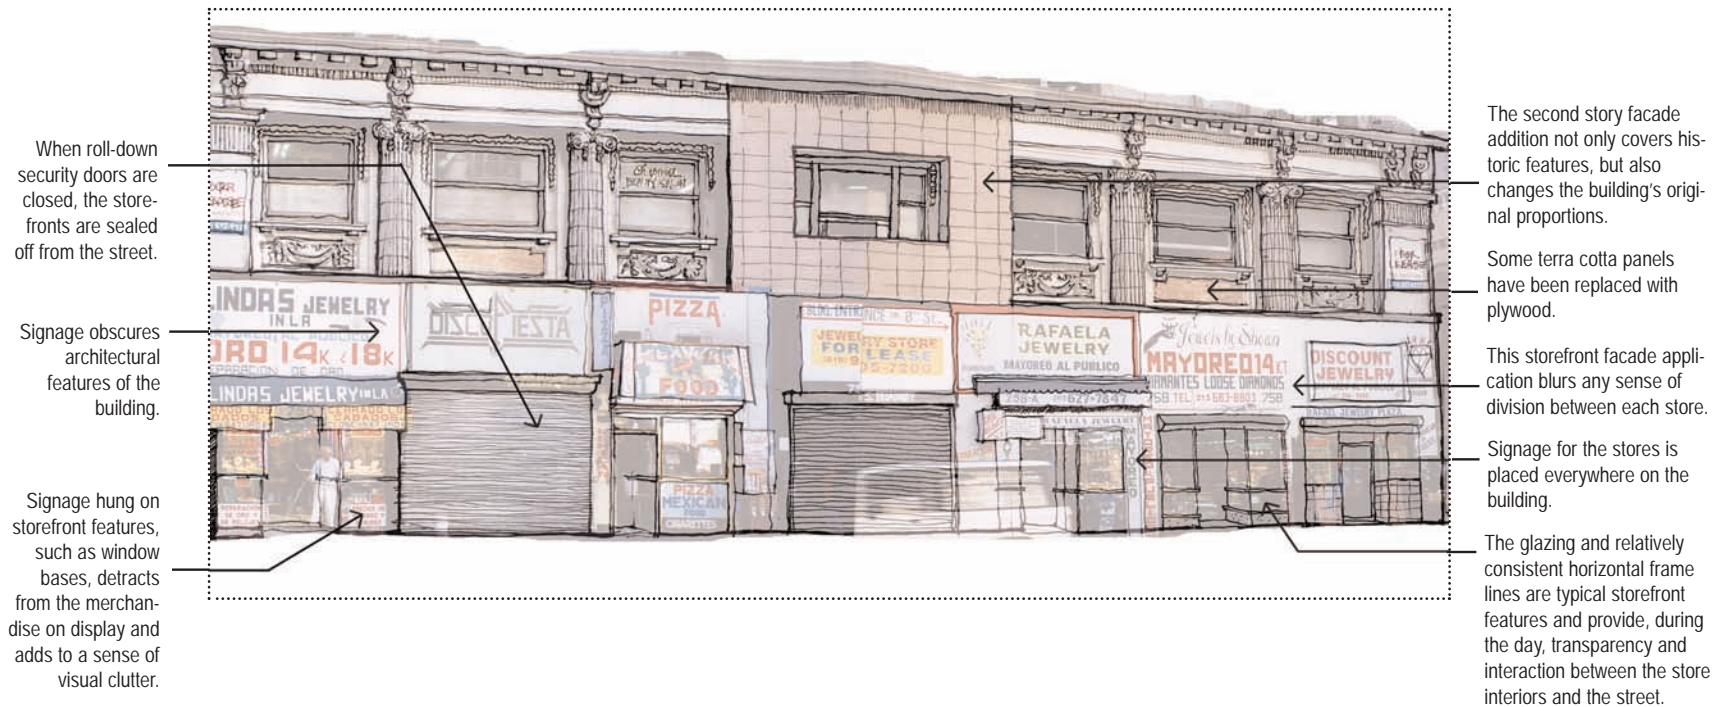
The main problems found on most jewelry storefronts are:

- Facade additions are top heavy, covering architectural features and changing building proportions.
- Signage is placed randomly all over buildings, blurring individual merchant storefronts.

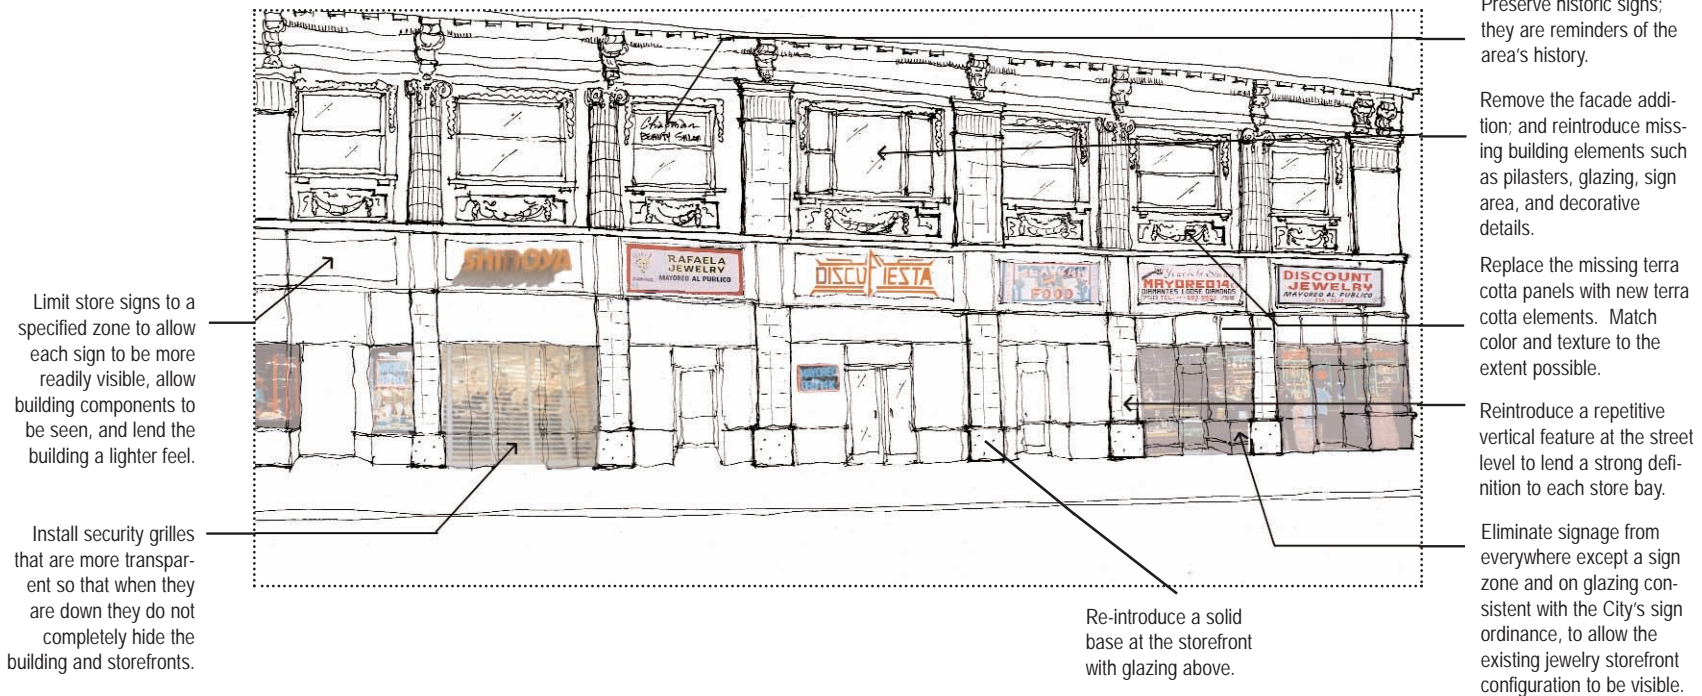
JEWELRY STOREFRONT after

- Remove second-story center facade addition.
- Limit signage to the storefront sign zone.
- Reintroduce vertical features to define bays.
- Reintroduce missing architectural features and decorative elements with compatible materials.

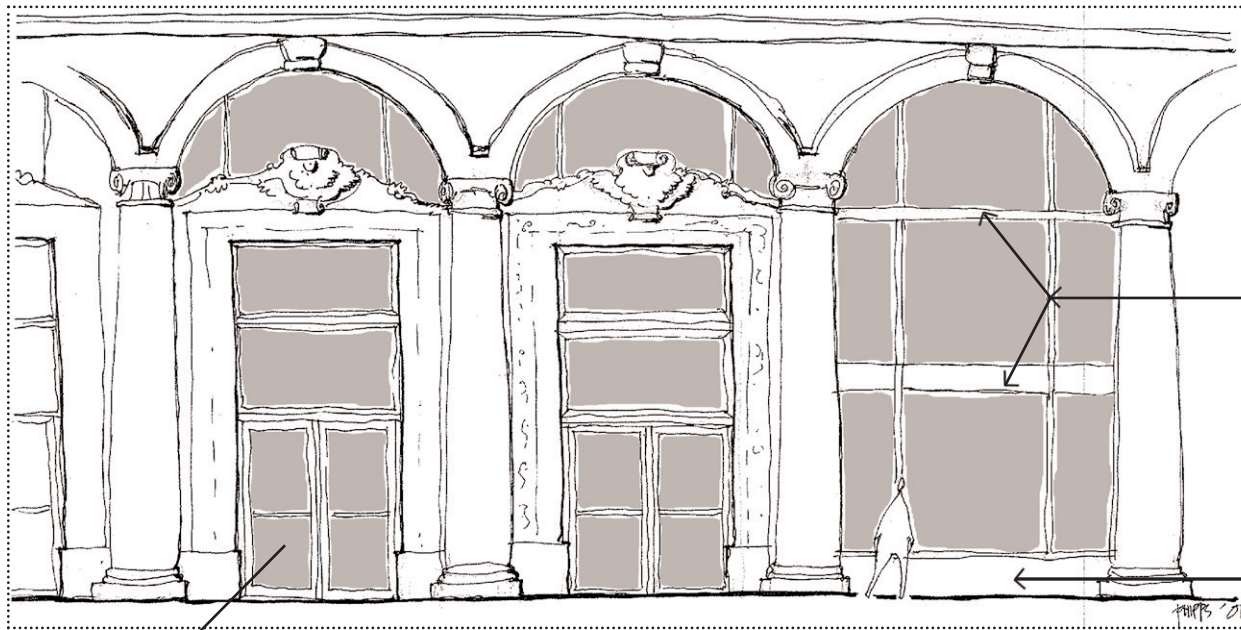
The clear storefront glazing has been replaced with black opaque glazing. As a result, the transparency of the storefront glazing has been lost.

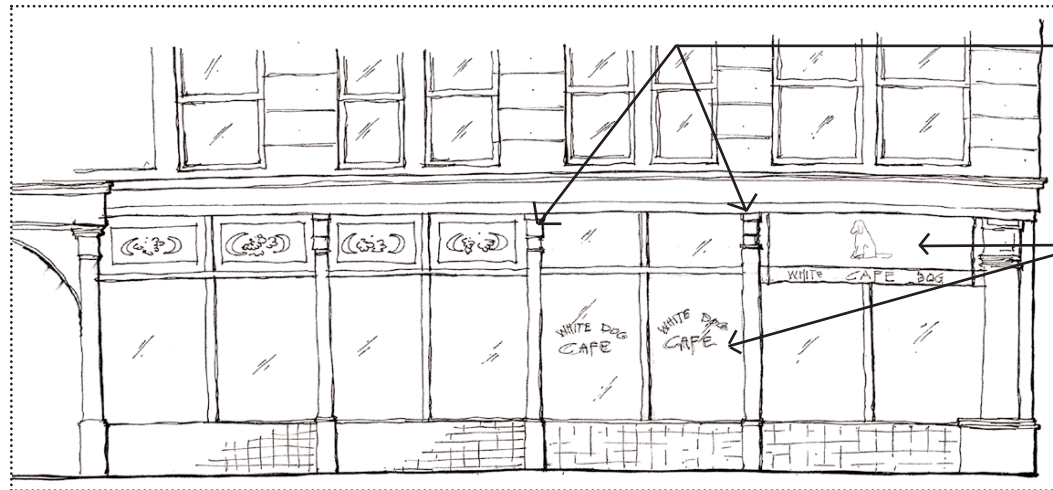
Maintain a clear definition of storefront bays; size elements such as awnings to fit between bay definitions (i.e. between the storefront columns.)

- Remove metal panels and clearly define each bay.
- Reintroduce the larger panes of storefront glass throughout.
- Provide a signage awning that fits within the spacing of a bay and incorporates the storefront's sign logo.

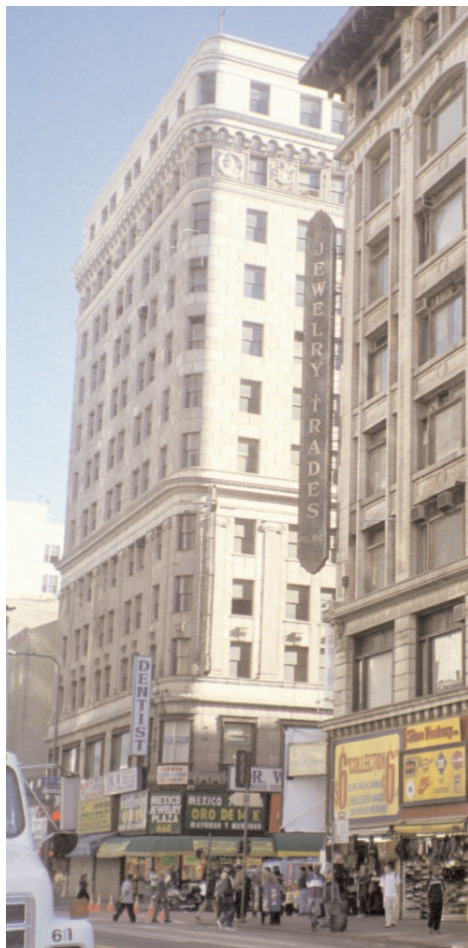
This corner building is a classic three-part commercial building consisting of the base, middle, and top. A phased approach to rehabilitation of this structure could start with the storefronts, then move to the upper stories, including terra cotta and window survey and then repair, if necessary.

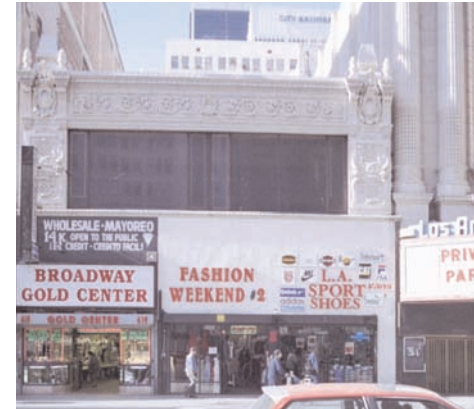
The Los Angeles Theater has two storefront components that flank the auditorium lobby. Shown above are the historic elements and windows that remain at the south storefront.

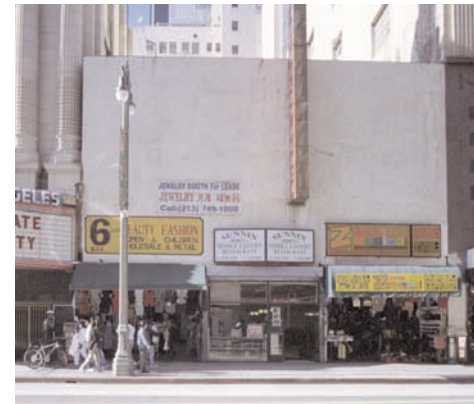
Unfortunately, the Los Angeles Theater's north storefront has been covered over. Testing, as a first step, may determine if any historic fabric remains. If no material remains, the south storefront could be used to pattern elements and replicate missing features.

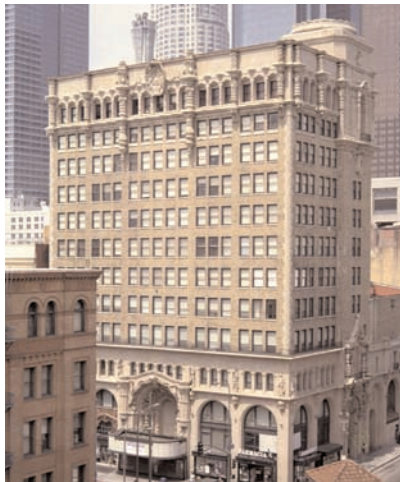
The heavy **base** of the Million Dollar Theater Building carries the structure with graceful arched openings into which are set the theater entrance and storefronts.

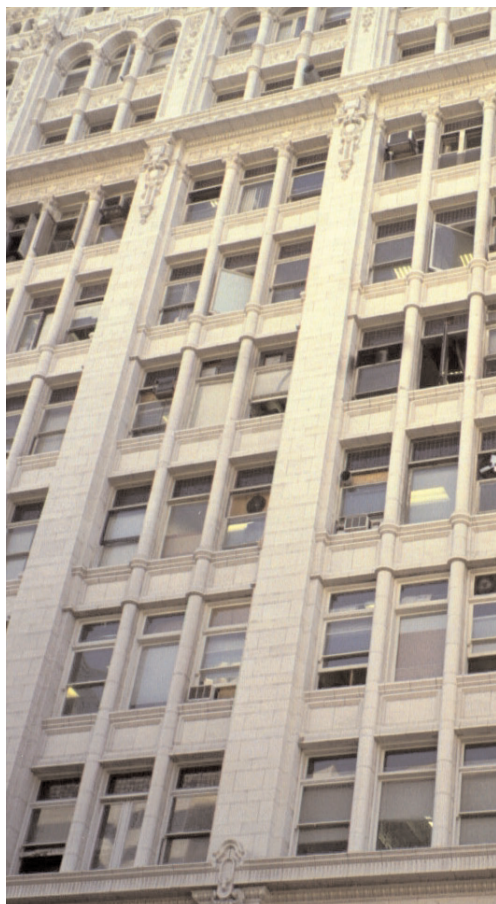
The upper story windows on this building have a number of problems that are common throughout the study area, including sporadically placed air conditioning units, items stored in front of windows at interior spaces, and broken or non-operational windows.

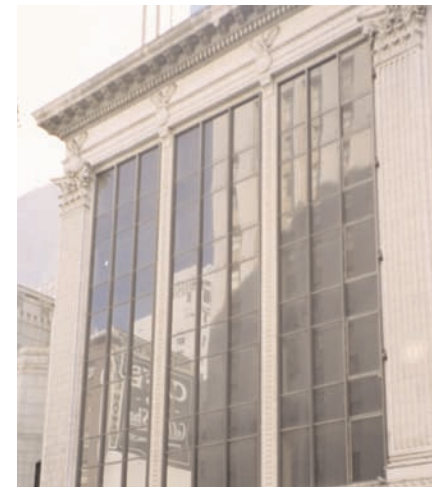
This building has tinted replacement windows that diminish the intended lightweight nature of the structure.

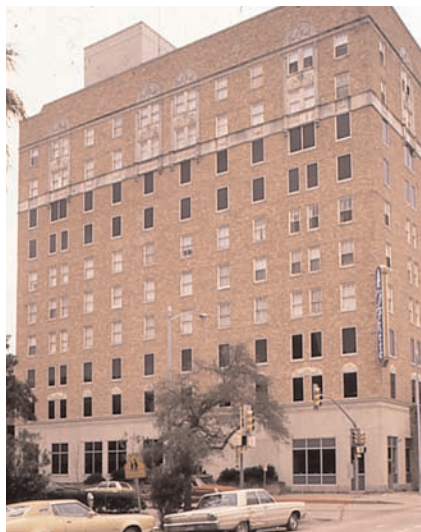
This building has tinted replacement windows that read as dark voids from a distance. This kind of treatment is inappropriate as it greatly alters the facade.

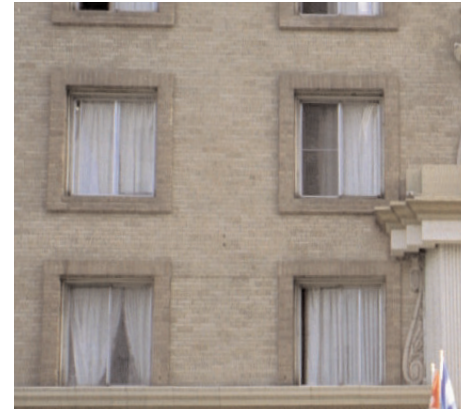
These replacement aluminum windows do not provide the same sense of detail or scale to the building facade as the originals. The lack of window mullions disturbs the facade proportions.

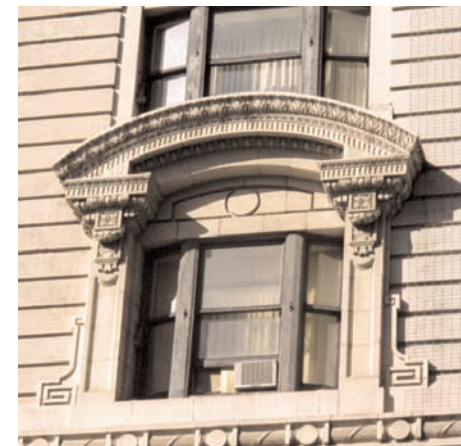
Simply cleaning and painting these wood windows would greatly improve the appearance of this building facade.

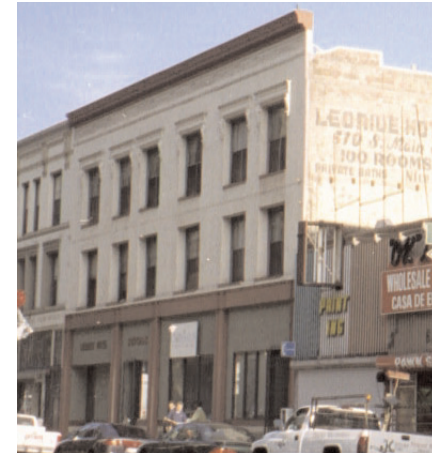
This building has a high parapet at the front facade that will serve to screen any rooftop mechanical equipment of a certain height.

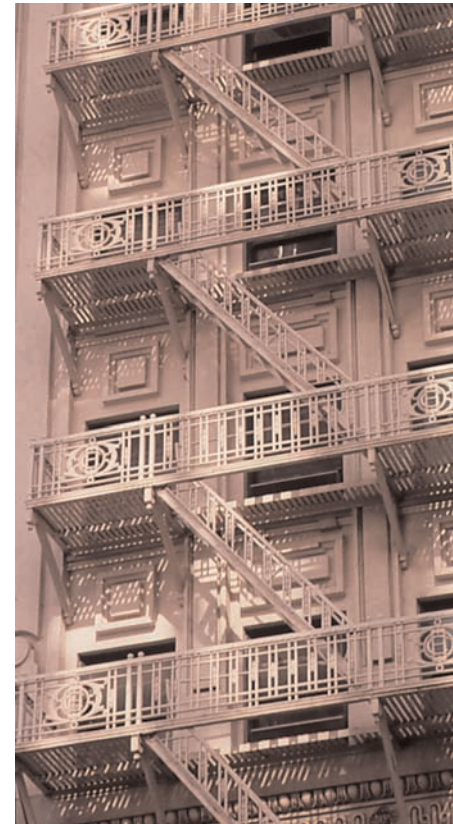
An intricately detailed metal fire escape is one of the most dominant features of this particular building. This element should be retained even if it is no longer used for emergency exiting.

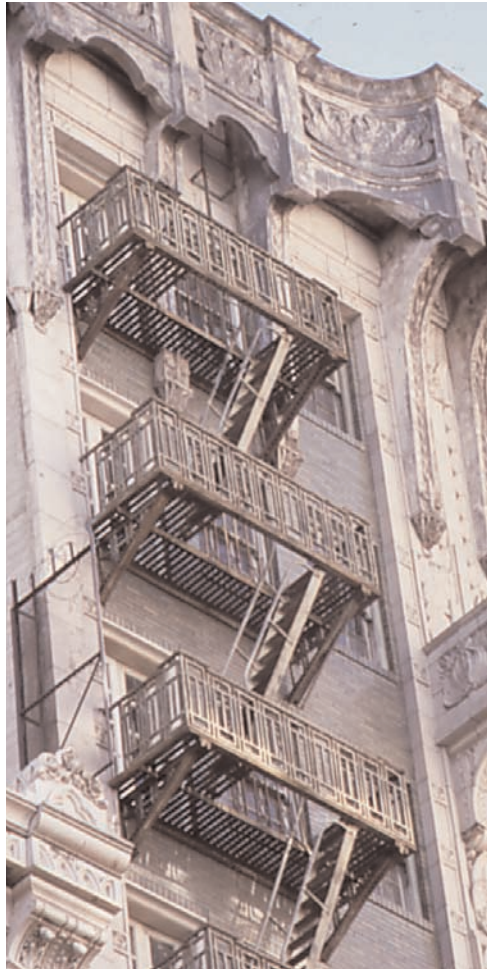
The above fire escape, though not as decorative as the one shown on the previous page, is a character-defining feature of this facade.

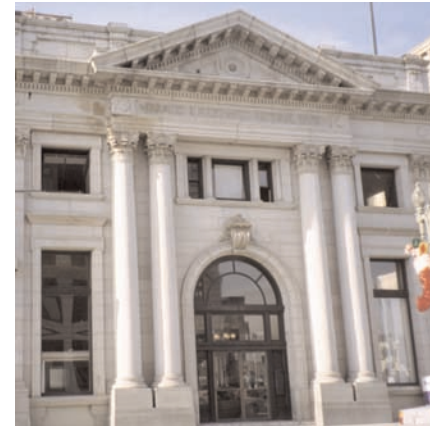
Cast stone is commonly used for very large building elements such as the columns on the historic Farmers & Merchants Bank.

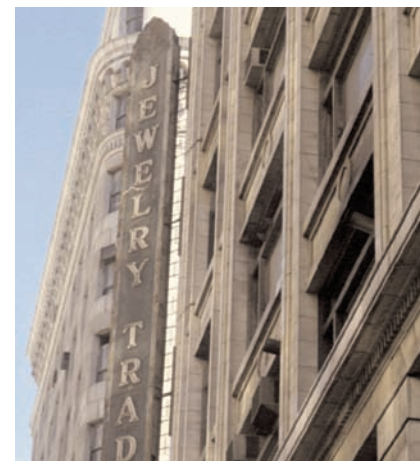
The Jewelry Trades building sign is metal and it is anchored to the building with metal ties into the terra cotta.

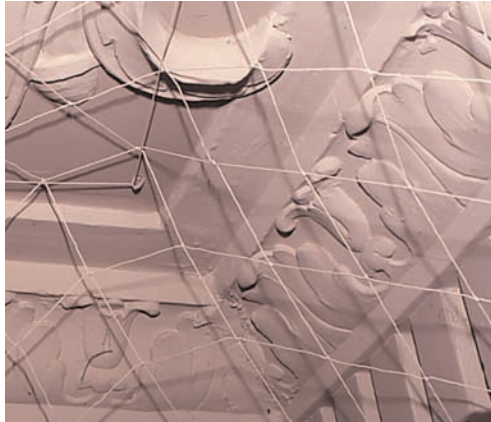
This nylon mesh system provides temporary protection from falling plaster until rehabilitation can be undertaken.

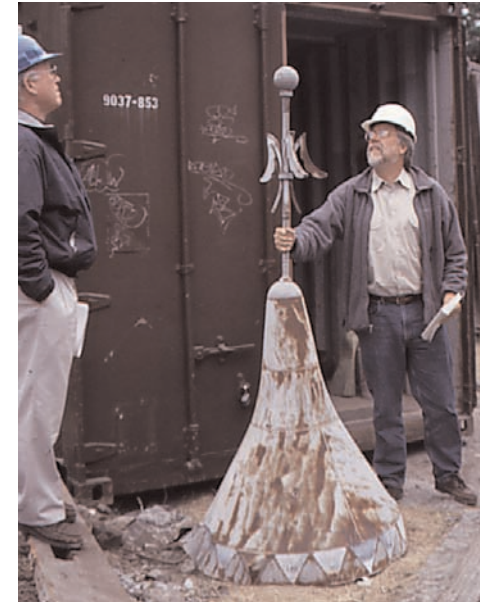
Architectural features that are in jeopardy of dislodging from buildings should be removed and temporarily stored until they can be permanently repaired.

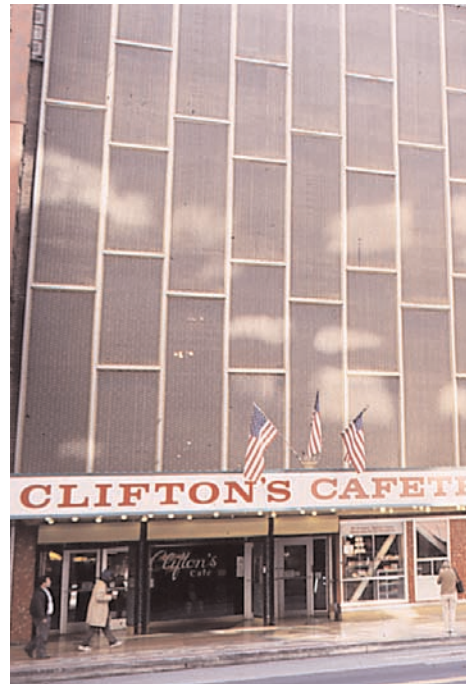
An historic facade is present behind the Clifton's Cafeteria building screen. A rehabilitation project in the future could remove the screen to reveal what is behind, and the features that remain could be rehabilitated and missing features could be re-introduced.

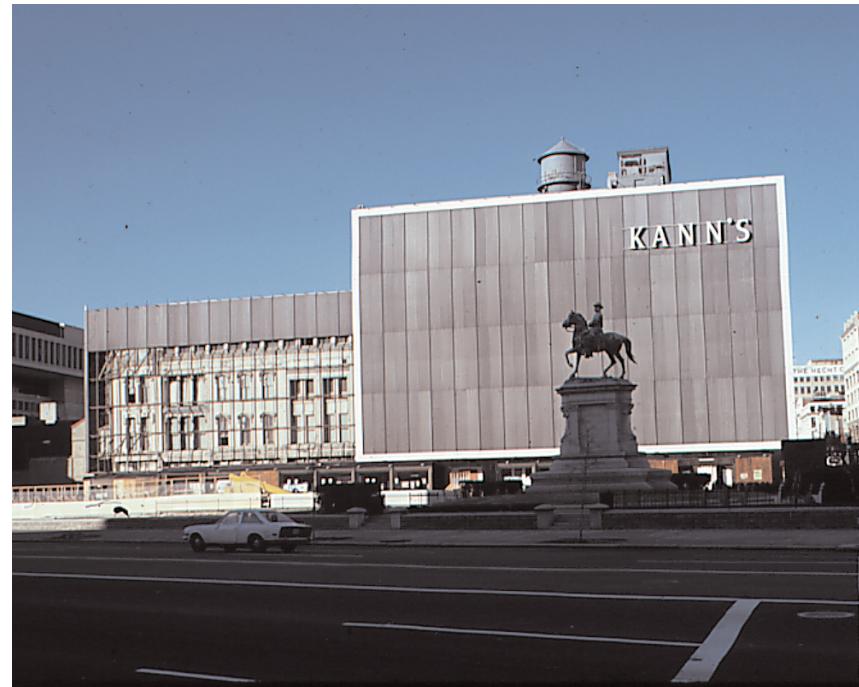
This department store in the midwest underwent facade rehabilitation. In this photograph, the historic building is visible on the left while the screen remains on the right.

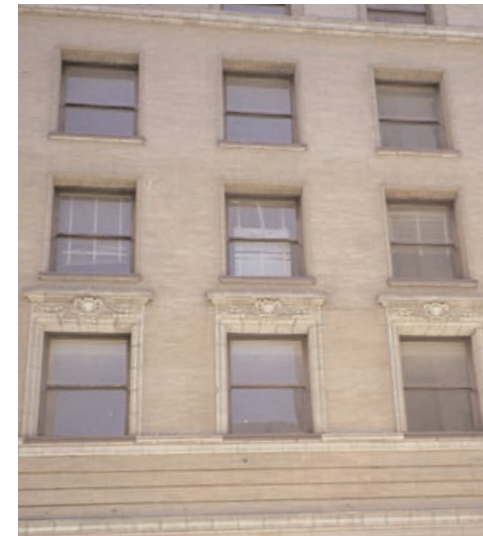
A detail of the Third Street elevation of the Douglas Building showing the terra cotta caps above the windows, the window condition, and the storefront cornice.
